Photographs and Descriptions

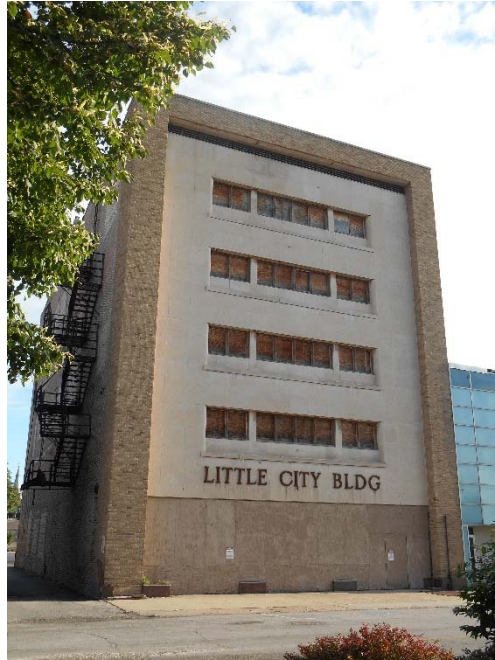
Photograph No. 1. Looking north at south elevation.

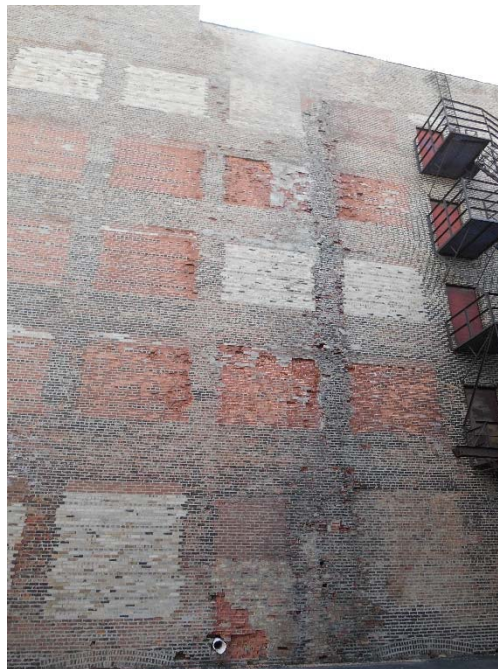
Photograph No. 2. Looking east at west elevation showing infilled windows, brick spalling, and missing bricks and mortar.

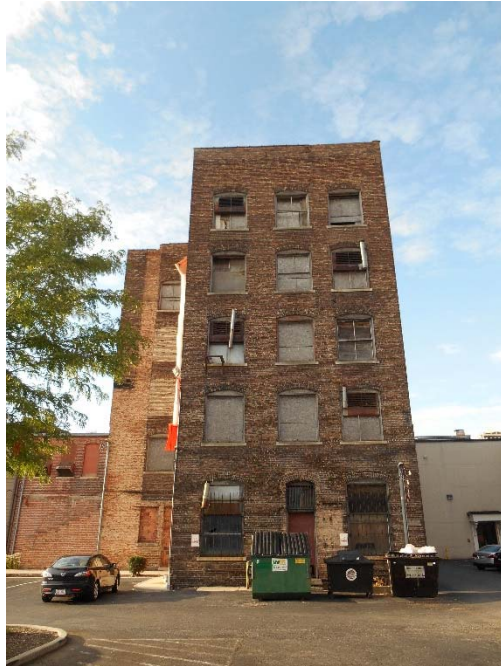
Photograph No. 3. Looking south at north elevation, including cut back section.

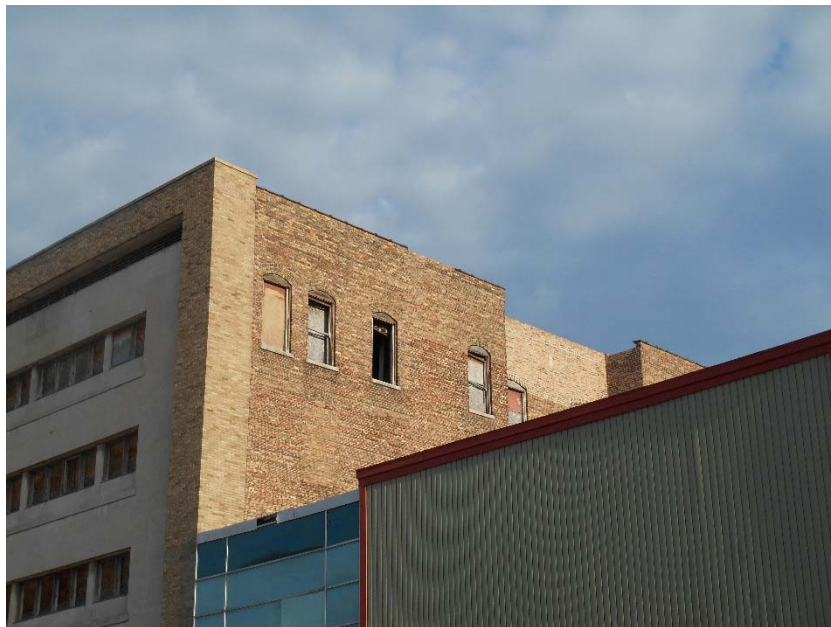
Photograph No. 4. Looking west at south portion of east elevation.

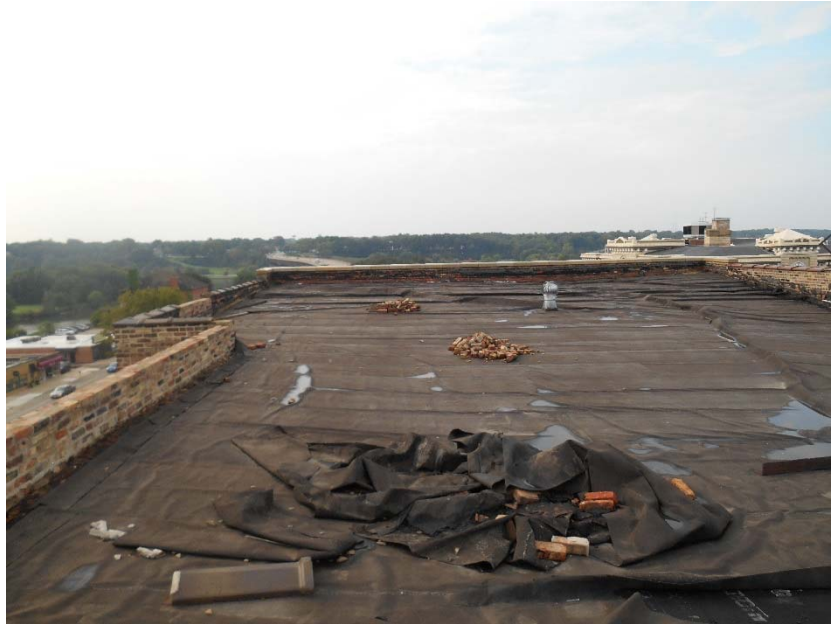
Photograph No. 5. Looking south at roof from north end. Not detached roofing and lack of parapet cap along east wall.

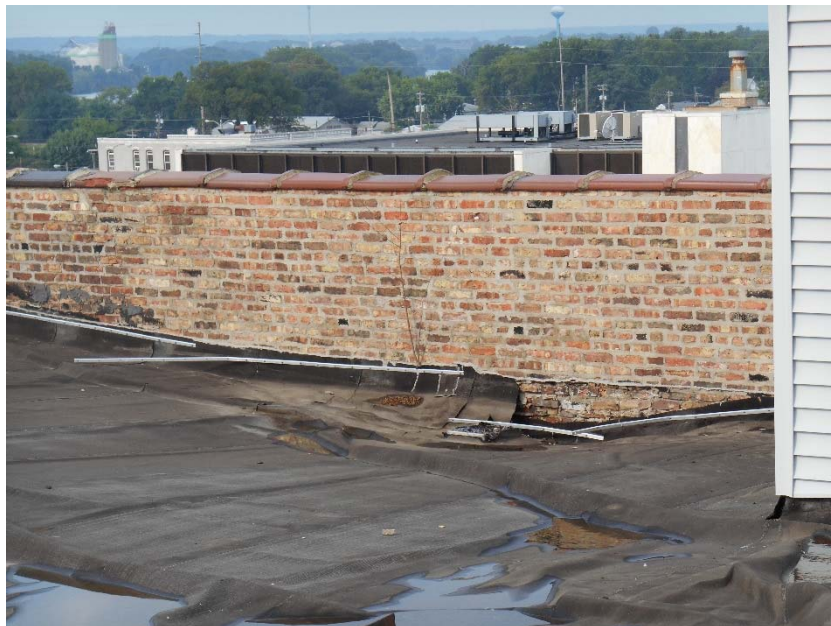
Photograph No. 6. Looking west at low spot in roof where roof drain connects. Note loose and disconnected roofing.

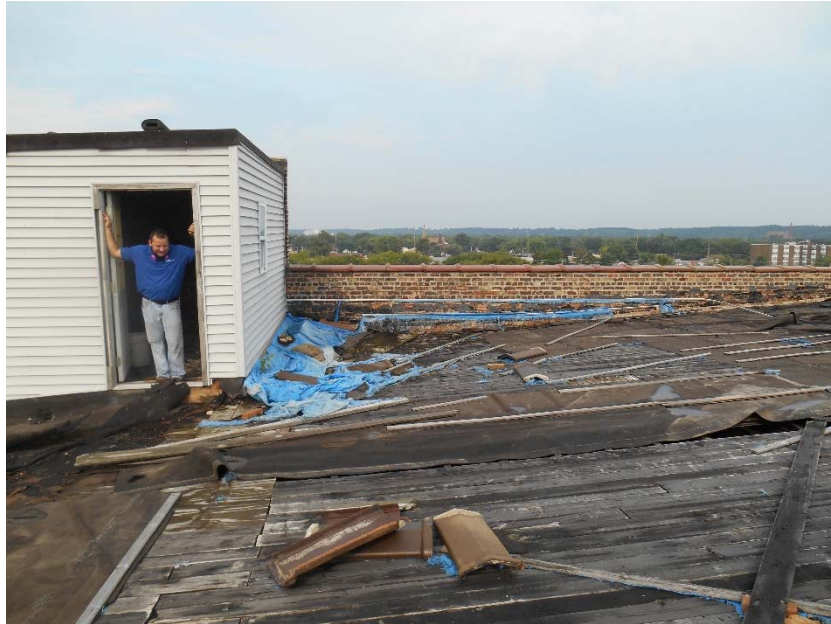
Photograph No. 7. Looking west at north end of roof. Note bare roof sheathing.

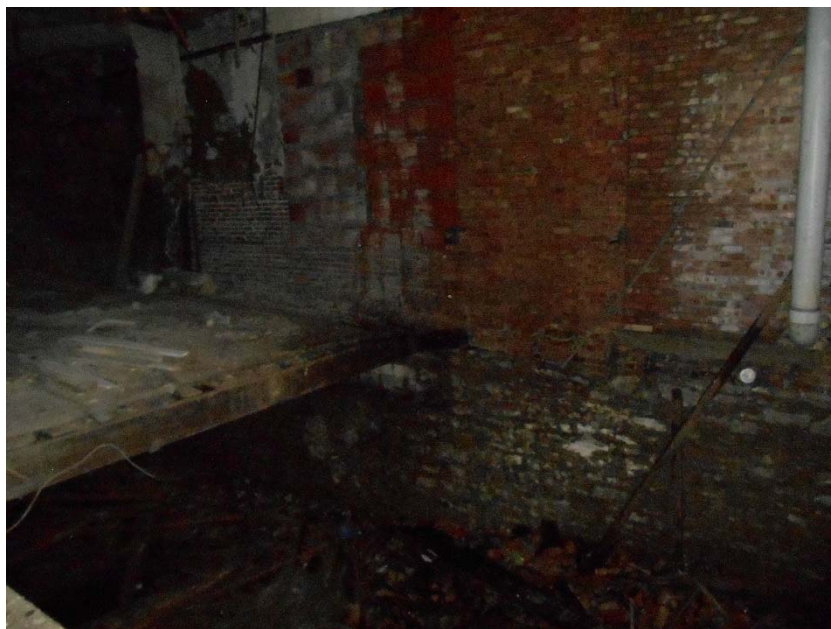
Photograph No. 8. Collapsed bay at first floor. Note sagging floor joists.

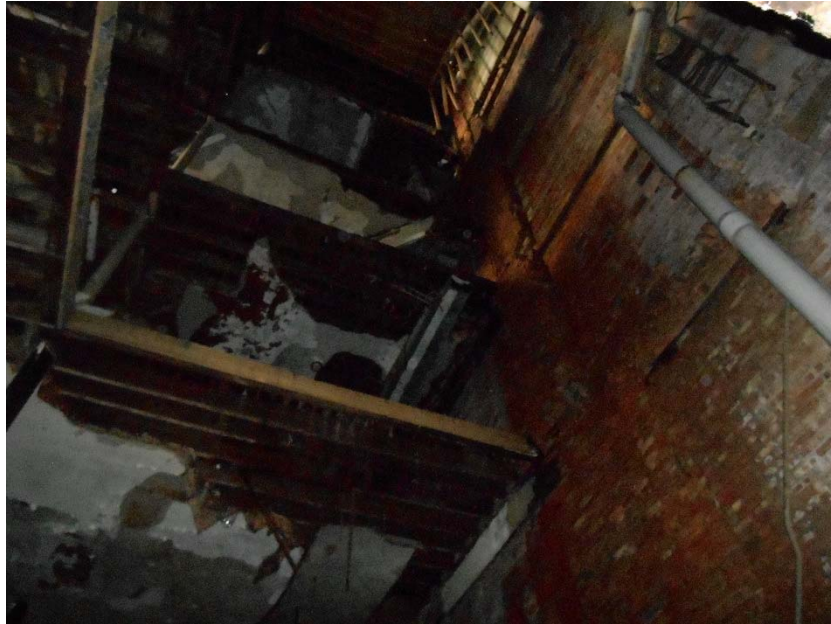
Photograph No. 9. Looking up along south side of collapsed bay.

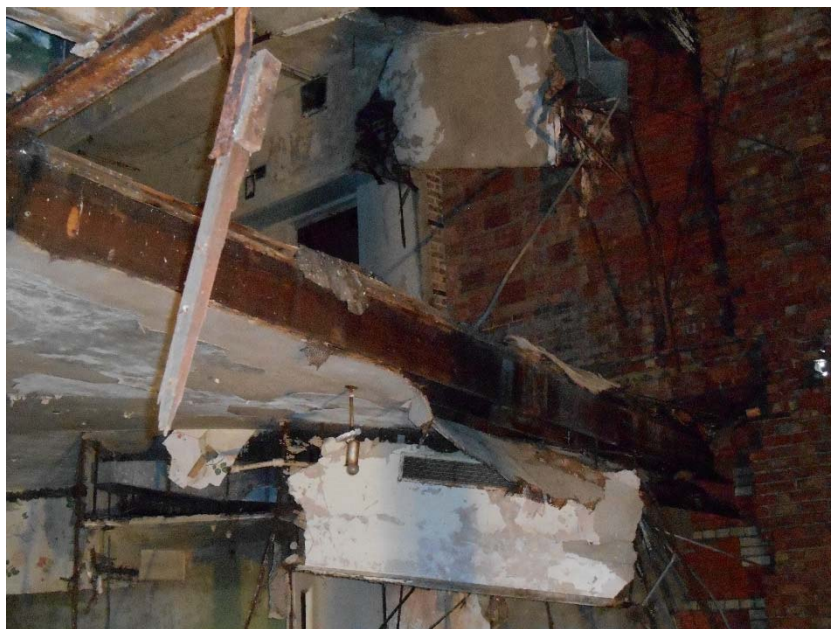
Photograph No. 10. Showing sagging floor at fourth floor level.

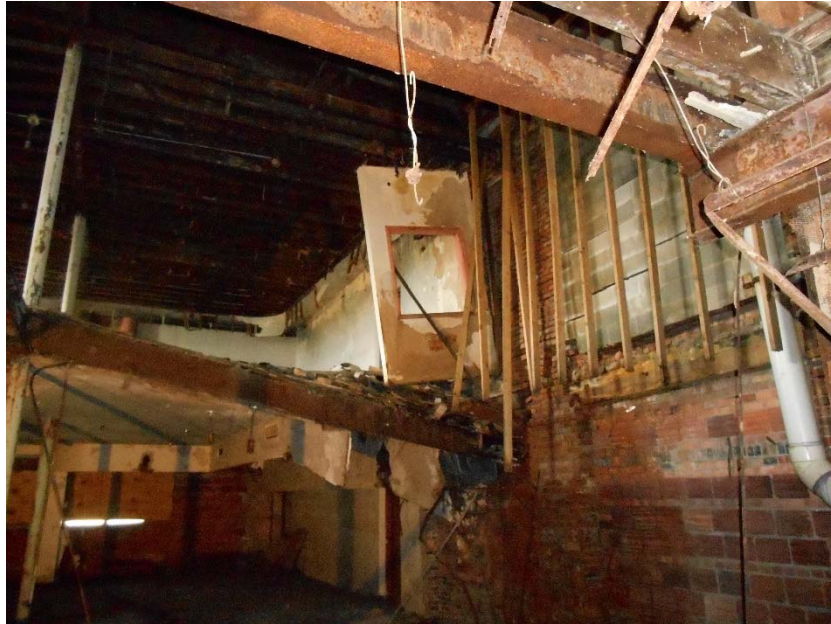
Photograph No. 11. Looking south along west wall, showing sagging at fifth floor level.

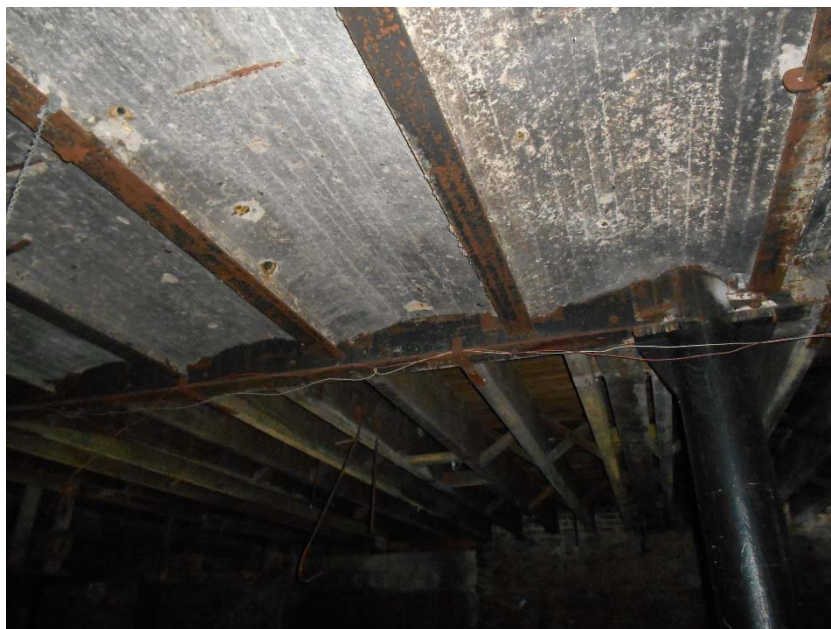
Photograph No. 12. Showing first floor framing from the basement. Note arched concrete in foreground and water stained joists in background.

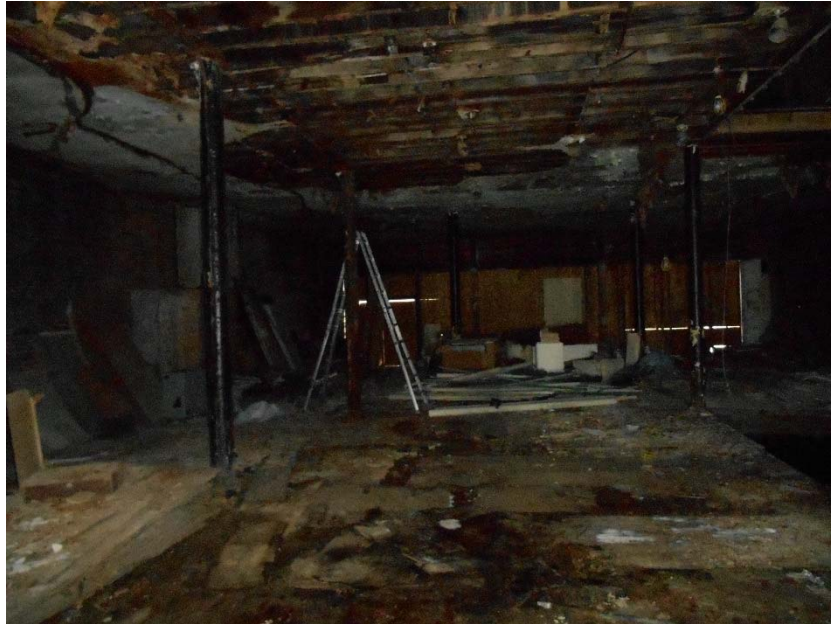
Photograph No. 13. Looking south along center bay. Note first floor water damage and water staining to second floor joists.

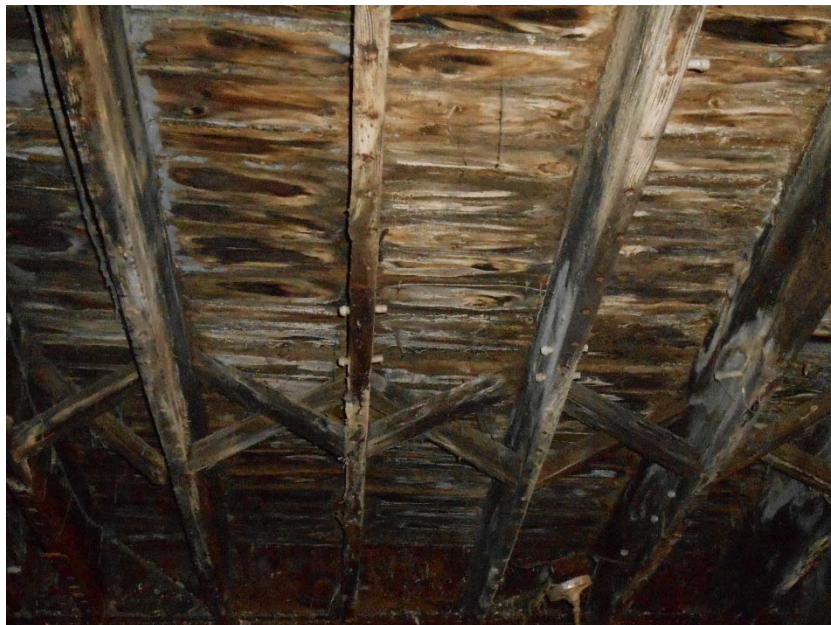
Photograph No. 14. Showing typical water staining to joists and decking.

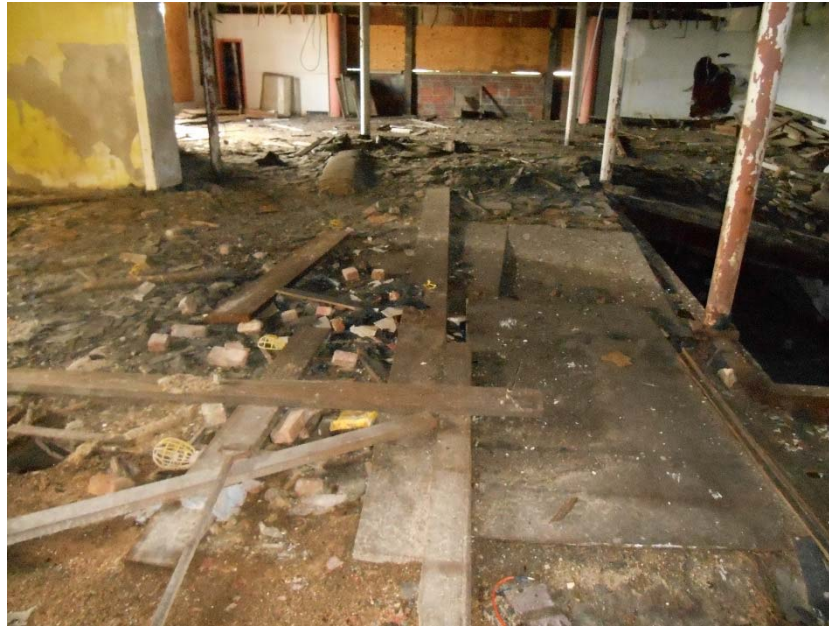
Photograph No. 15. Looking at second floor from below showing holes through deck.

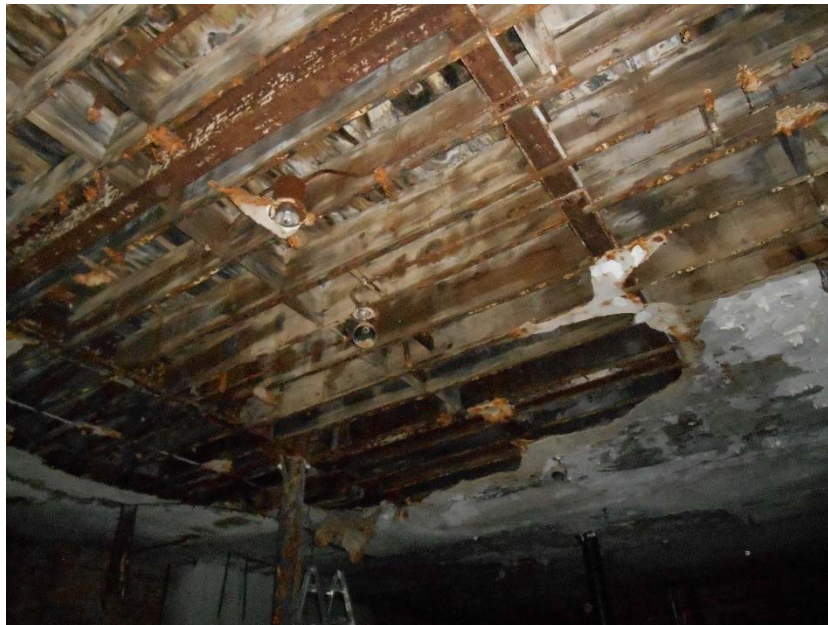
Photograph No. 16. Fifth floor showing deteriorated decking, particularly in the center bay.

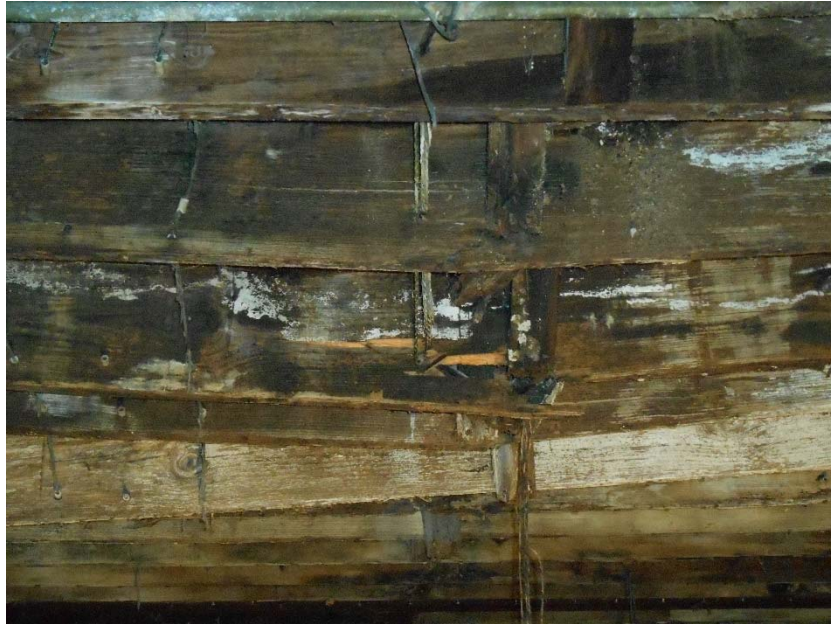
Photograph No. 17. Showing broken fourth floor joists near center of center bay.

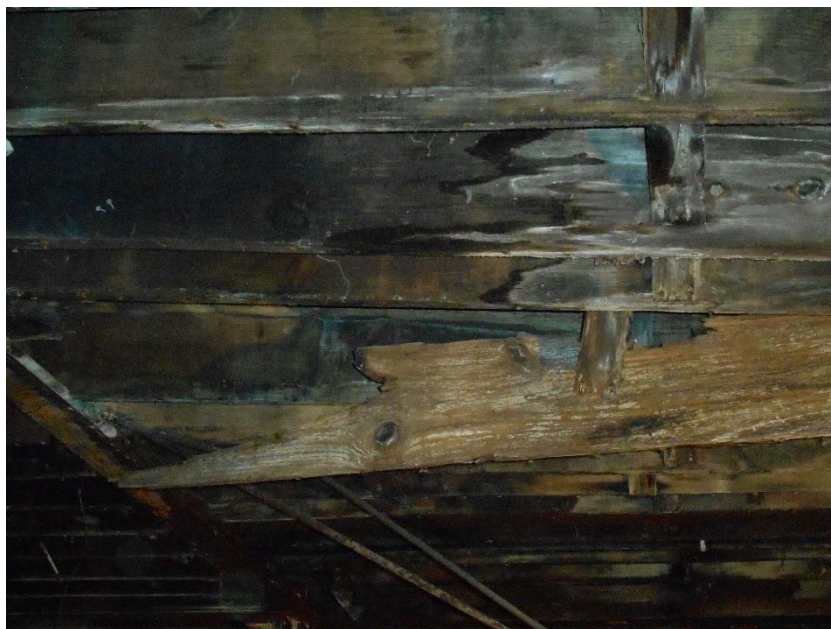
Photograph No. 18. Showing broken fourth floor joists near center of center bay.

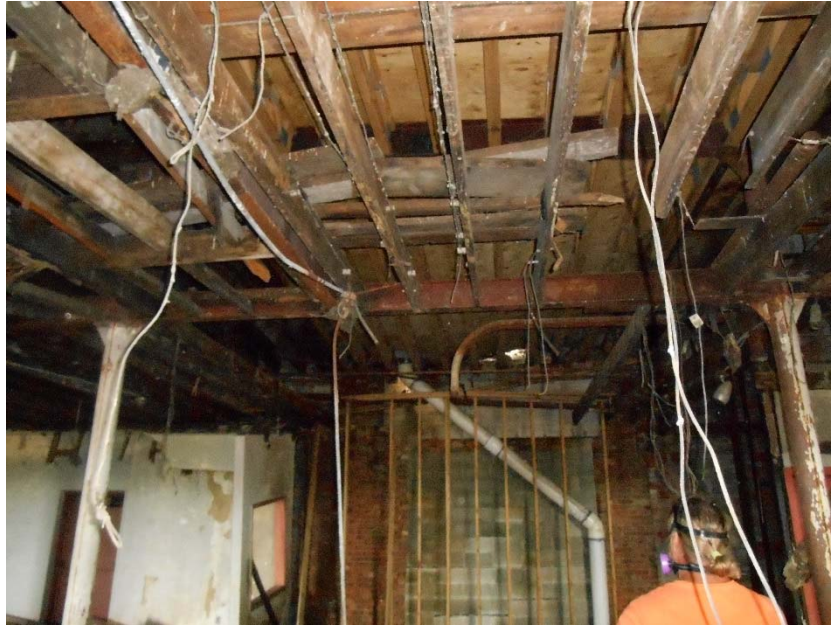
Photograph No. 19. Showing fifth floor ceiling joists and newer timber roof trusses.

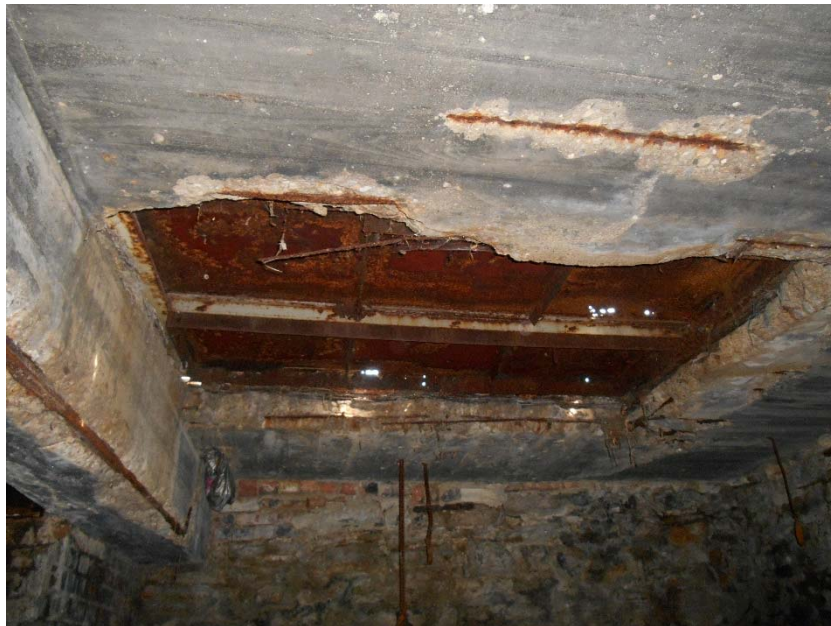
Photograph No. 20. Looking at bottom of access door in sidewalk from vault south of south elevation of building. Concrete beam to left supports the south wall.
